HISTORIC STRUCTURE REPORT

LAWNFIELD
HISTORIC STRUCTURE REPORT
JAMES A. GARFIELD NATIONAL HISTORIC SITE

Prepared by
Paul Newman

DENVER SERVICE CENTER
NATIONAL PARK SERVICE
UNITED STATES DEPARTMENT OF THE INTERIOR
DENVER, COLORADO

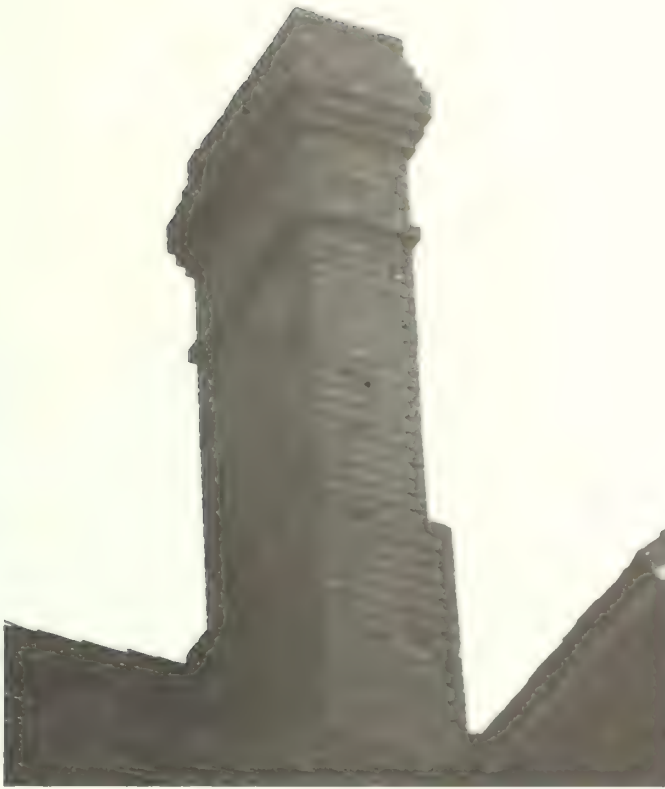
CP-9, Typical tall chimney unsupported above the roof. All chimneys need repainting.

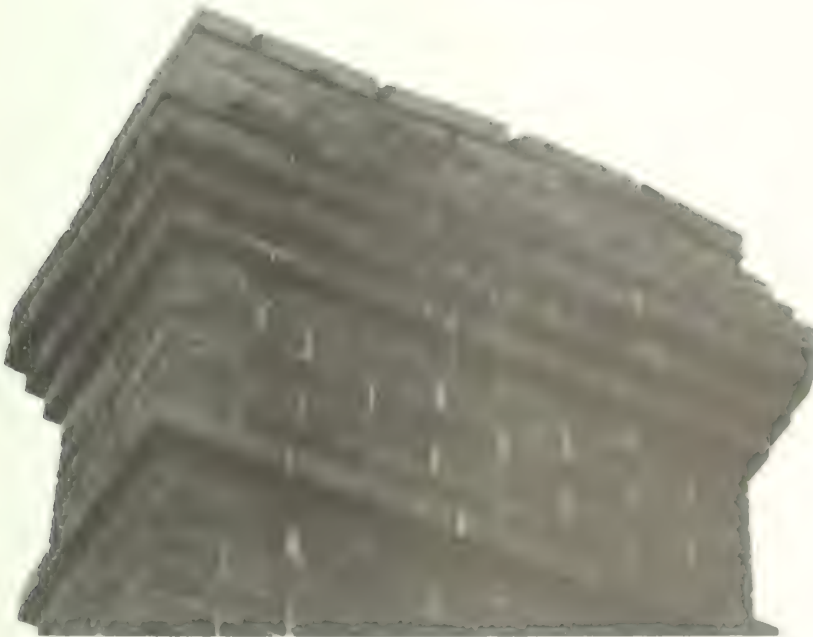
CP-10, Detail of corbeled chimney top. Severe weathering and leaching of mortar occur on of the chimneys.

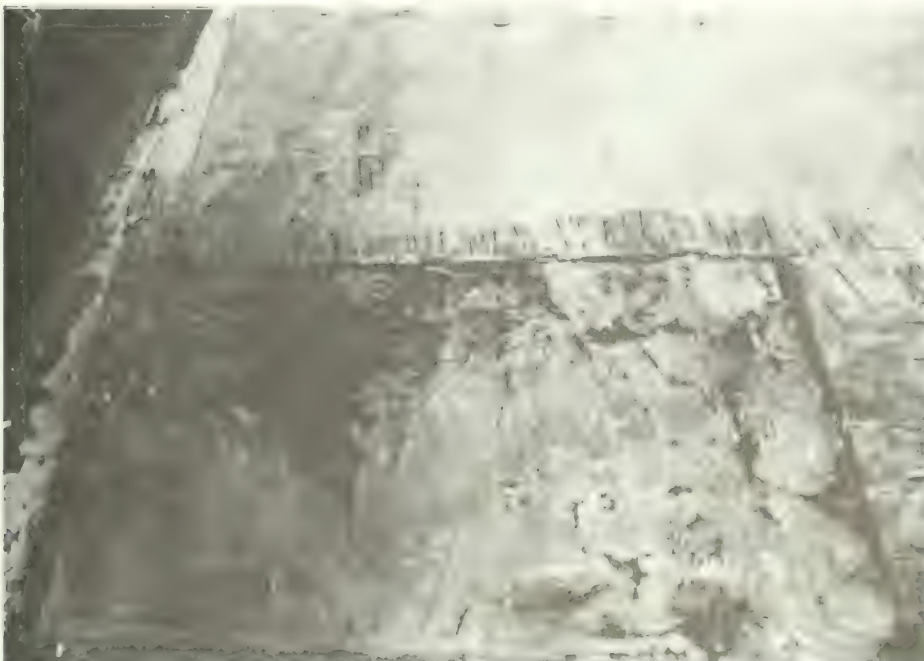
CP-18, Deteriorated roofing of the east porch.

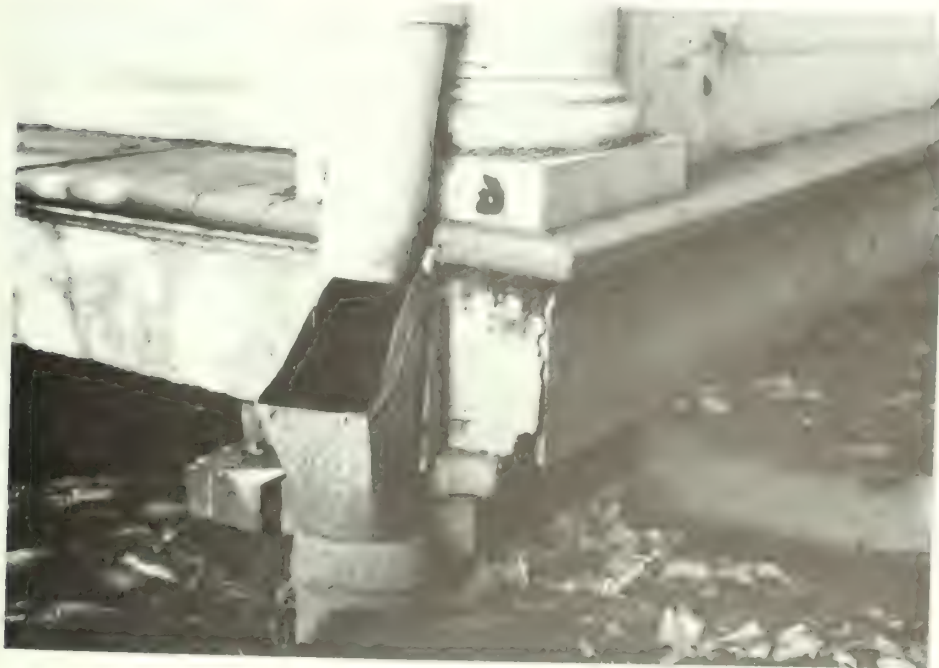
CP-25, East porch exhibits the same problems as the south porch.

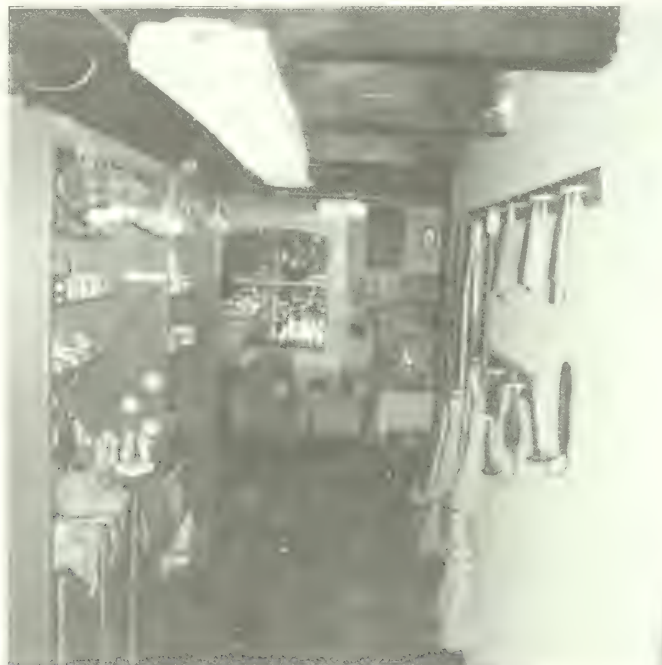
CP-59, A three-riser stair from the gift shop to the first-floor of the house is a barrier for wheelchair-bound visitors.

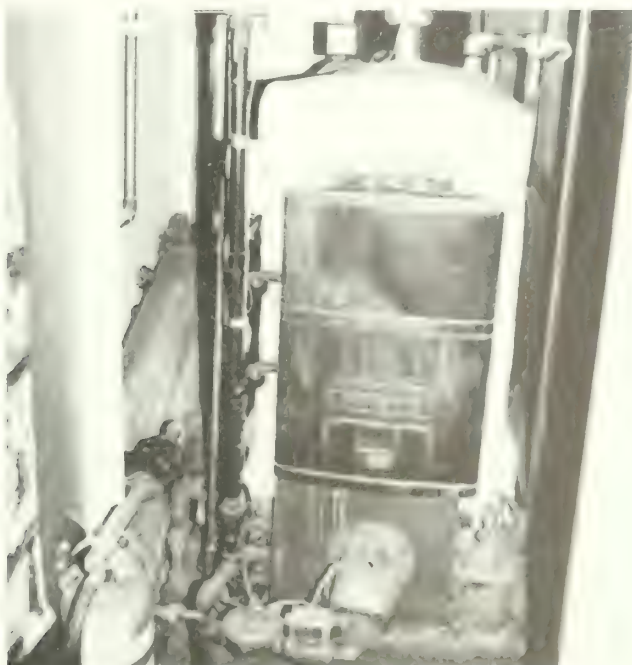
CP-61, Steam boiler is not separated by a fire-rated enclosure..

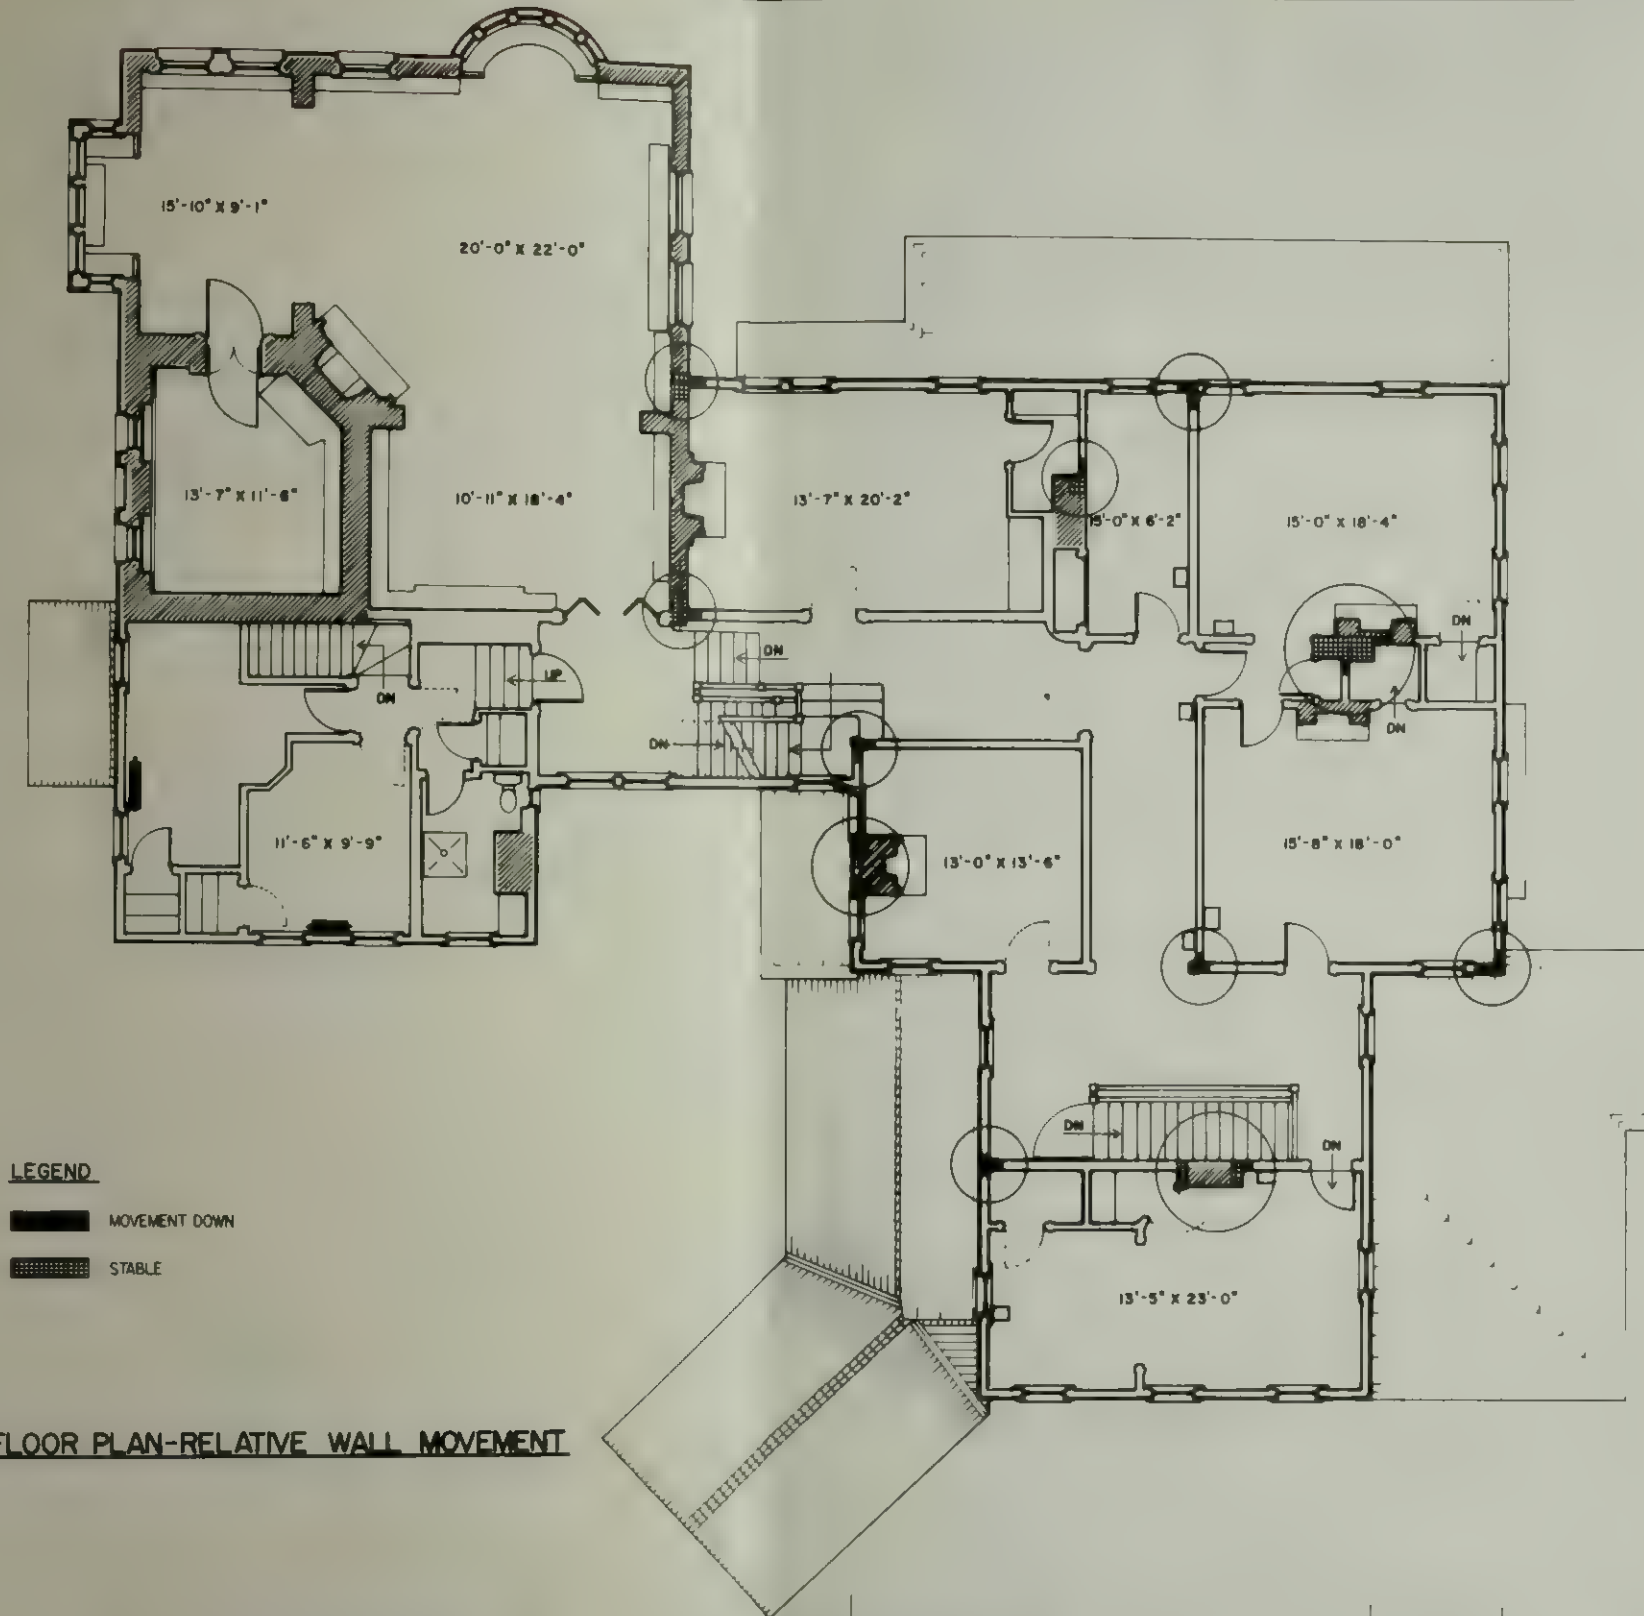
SECOND FLOOR PLAN-RELATIVE WALL MOVEMENT

RELATIVE WALL
MOVEMENT

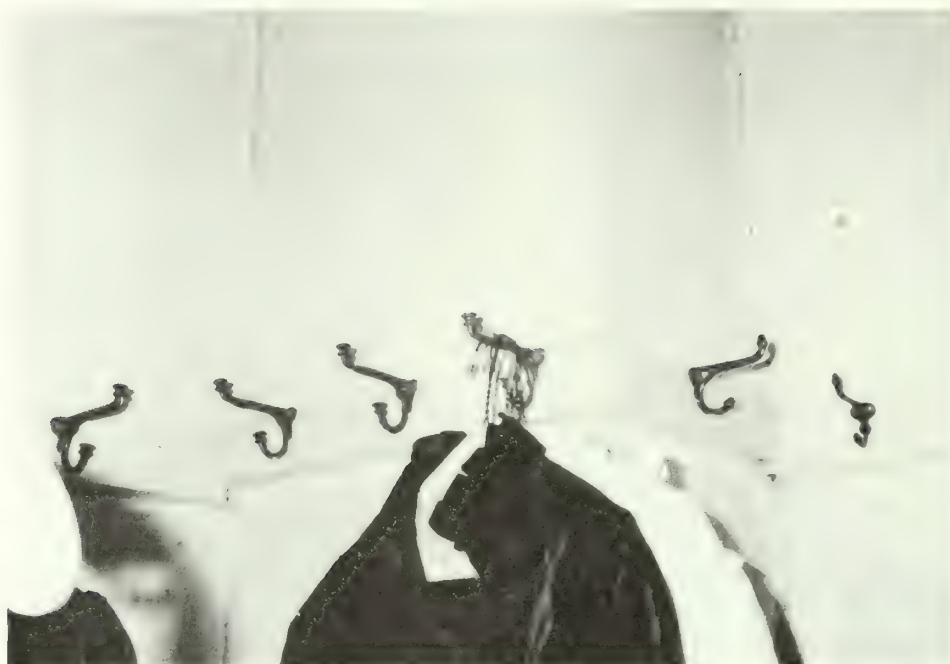
SP-11, Wall displacement, room 211.

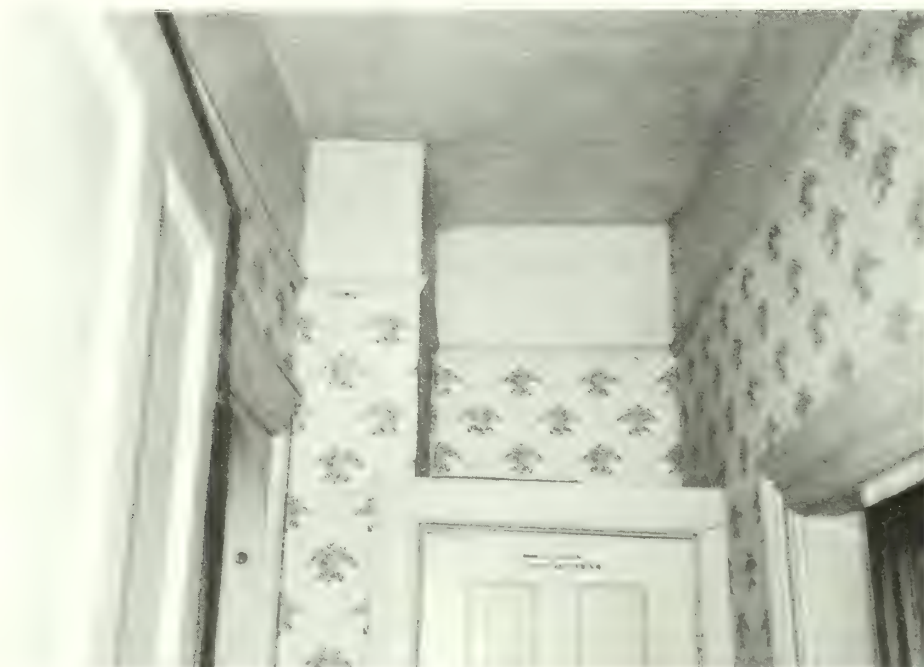
SP-12, Wall displacement, room 209.

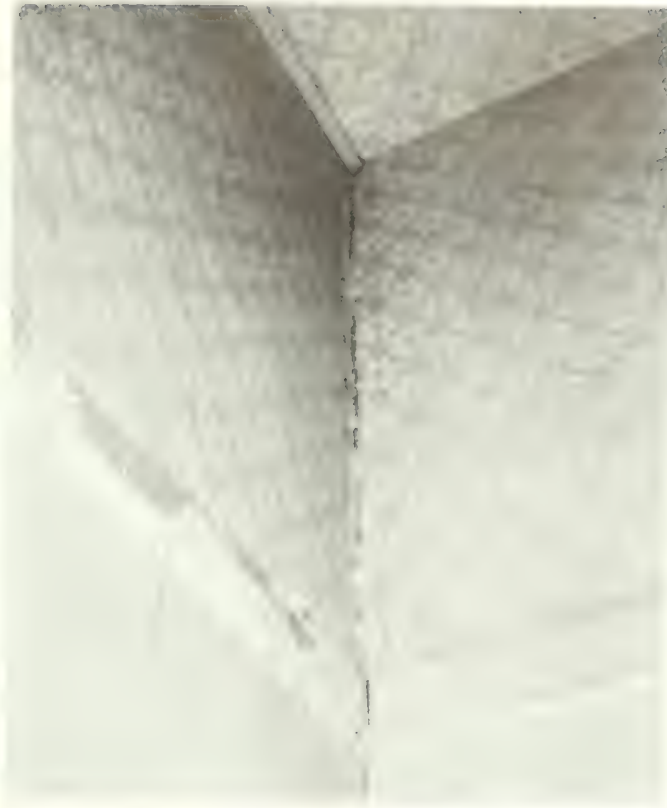
SP-13, Wall displacement, room 204.

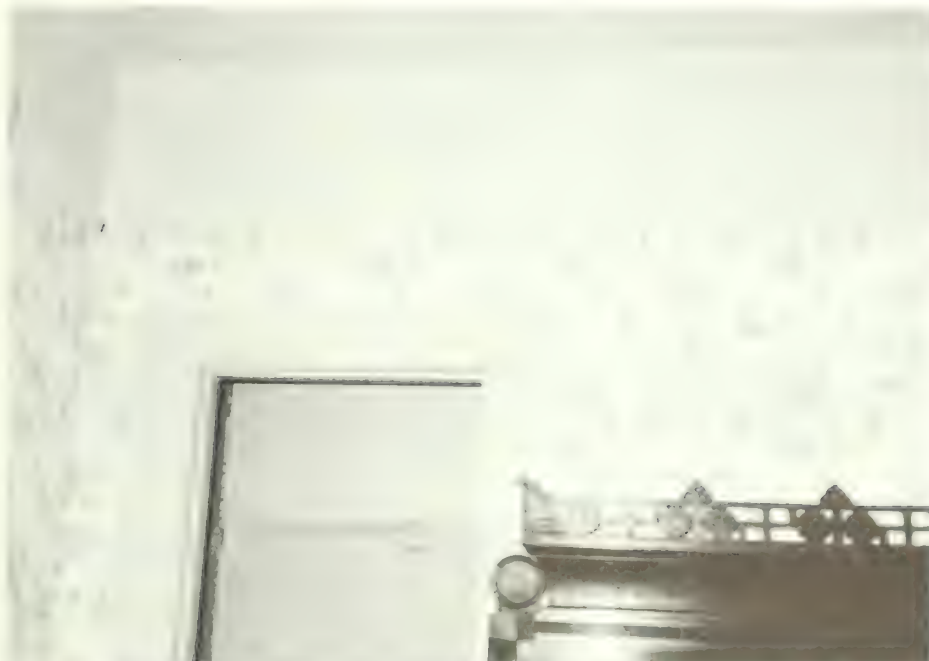
SP-14, Door displacement, rooms 203-204.

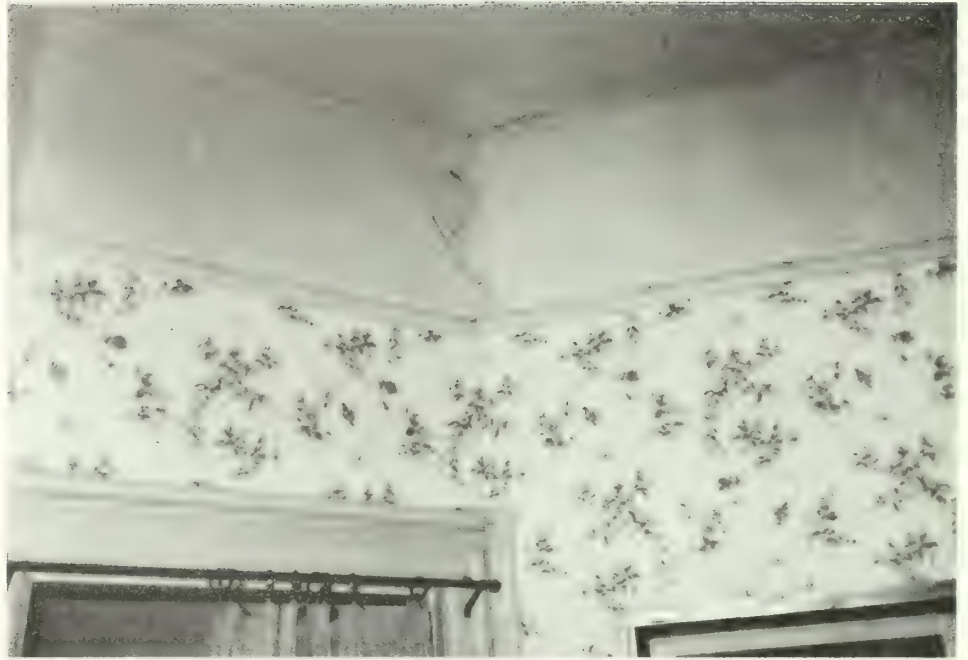
SP-15, Wall displacement, rooms 201-202.

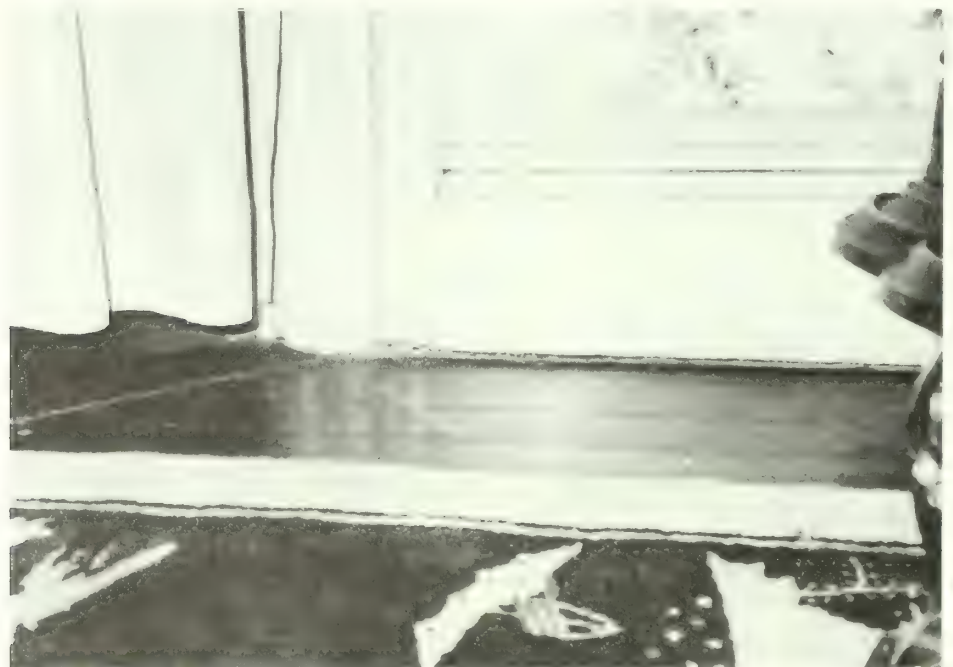
SP-16, Floor displacement, rooms 201-202.

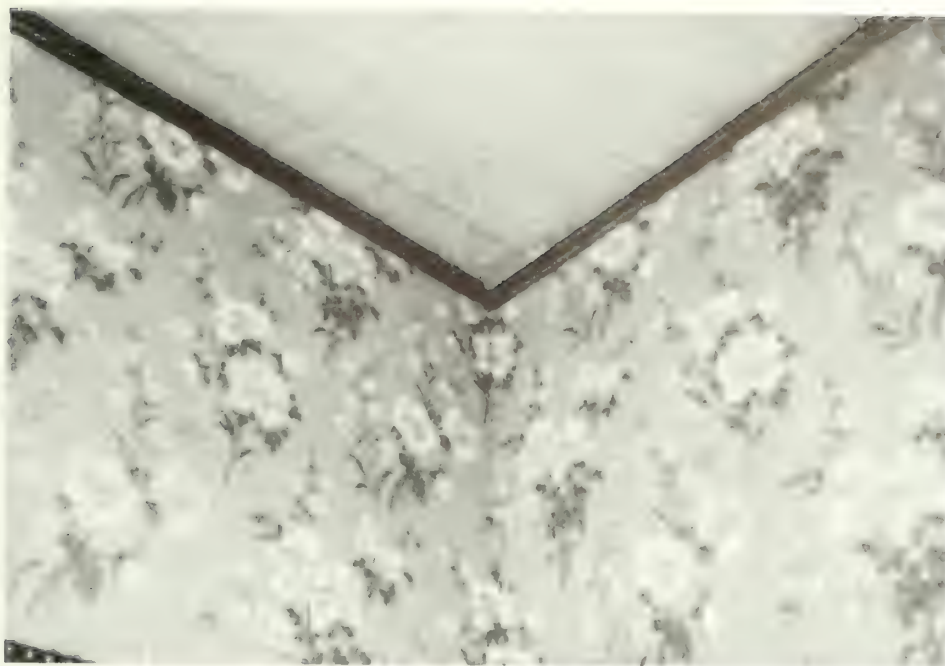
P-17, Wall displacement, northeast corner, room 216.

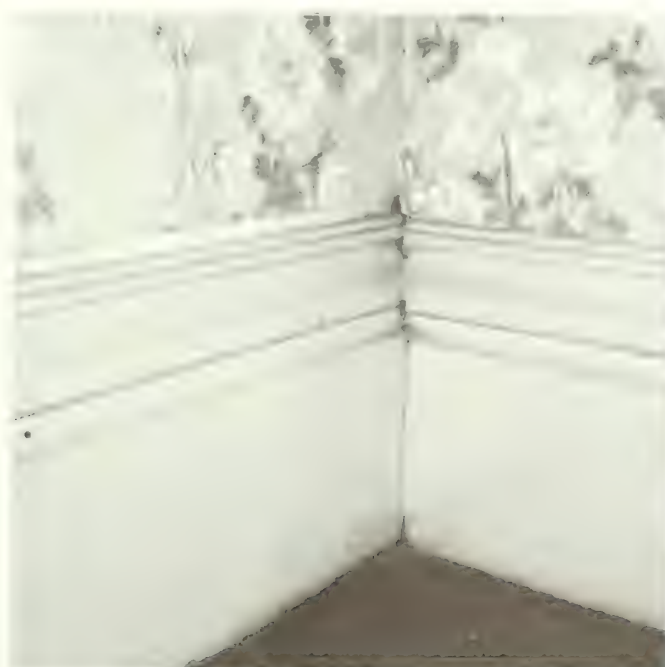
P-18, Floor trim displacement, northeast corner, room 216.

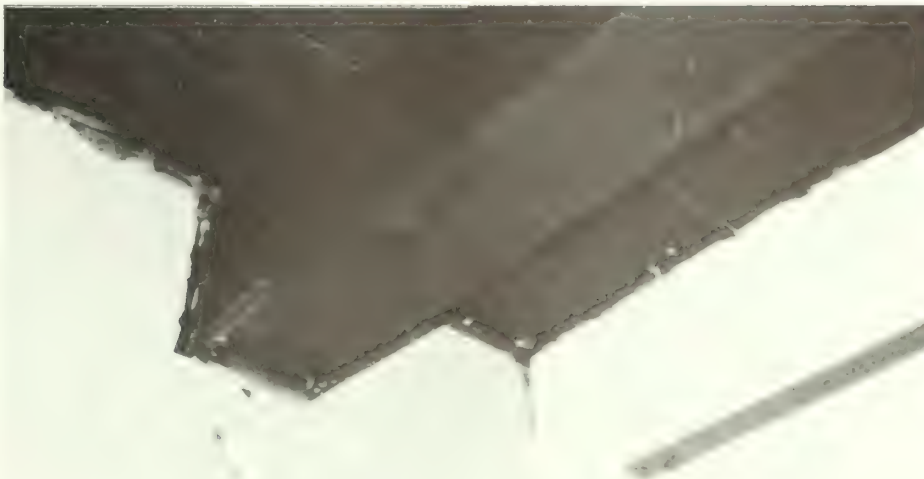
P-26, Library floor framing.

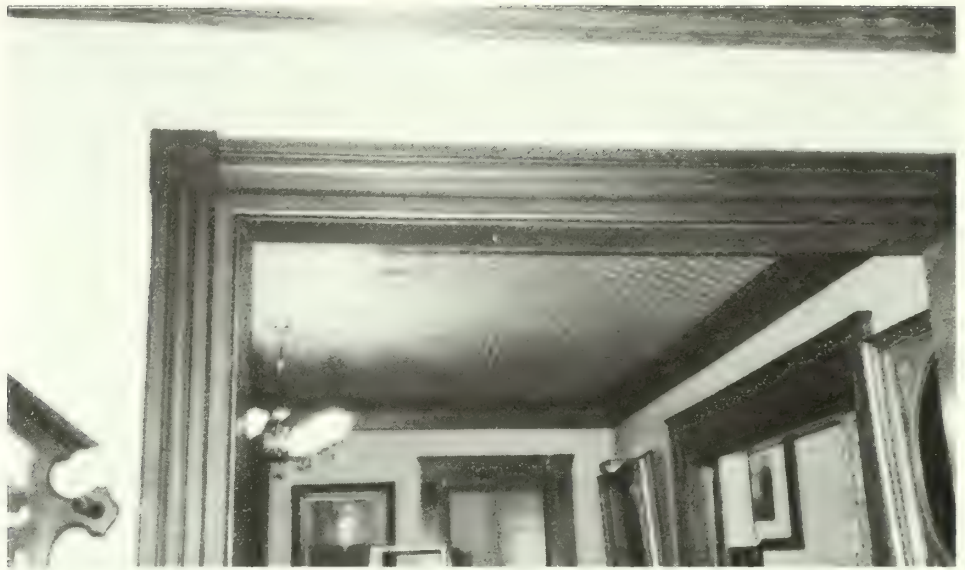
SP-27, Parlor ceiling at the beam.

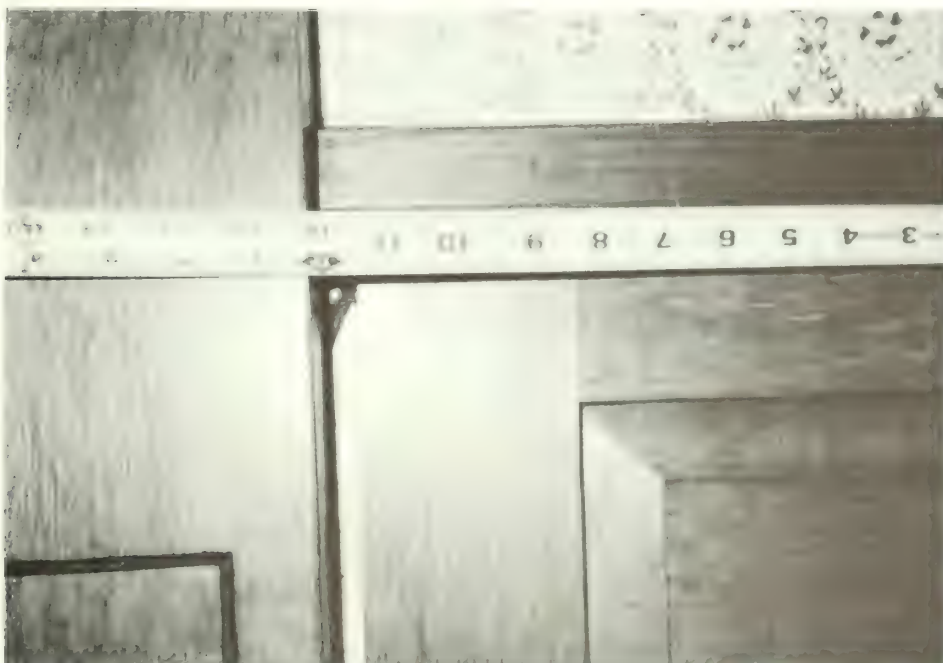
P-34, Main stair, panel displacement.

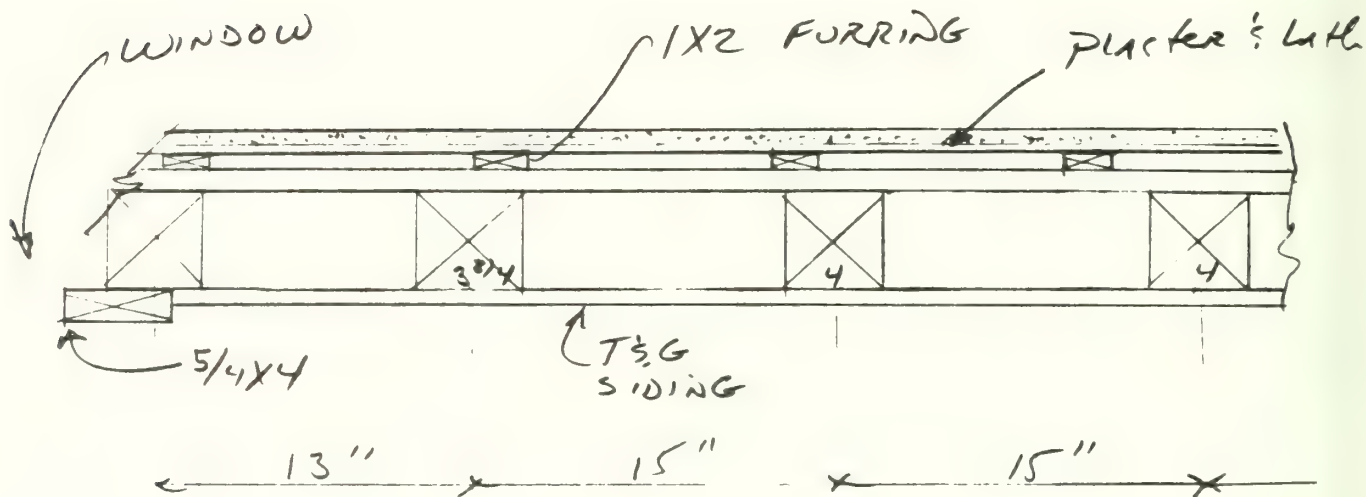
FIG 2

The exterior walls of the 1880 house are constructed of balloon framing with shiplapped exterior siding. Generally, the first level is framed with 3-inch by 4-inch poplar studs, 14 to 15 inches on center, with 2-inch by 4-inch fir studs interspersed (see plates SP-5 and SP-6). Studs are lap spliced at the second level to 2-inch by 4-inch fir studs and notched around the 2-inch thick ledger board which supports the second-floor framing (see "Appendix G, Structural Calculations," figure 1). The interior face sheathing is exterior shiplapped siding, placed horizontally in rooms 104 and 103, which probably was surplus material after the house was enclosed.⁷ The remainder of the interior sheathing is 1-inch by 10-inch or 1-inch by 12-inch on a 45° angle. The interior plaster and lath is attached to 1-inch by 2-inch furring strips which run vertically at 1-foot centers (see "Appendix G, Structural Calculations," figure 2).

Subject: Exterior Wall Section - East side Rm 107

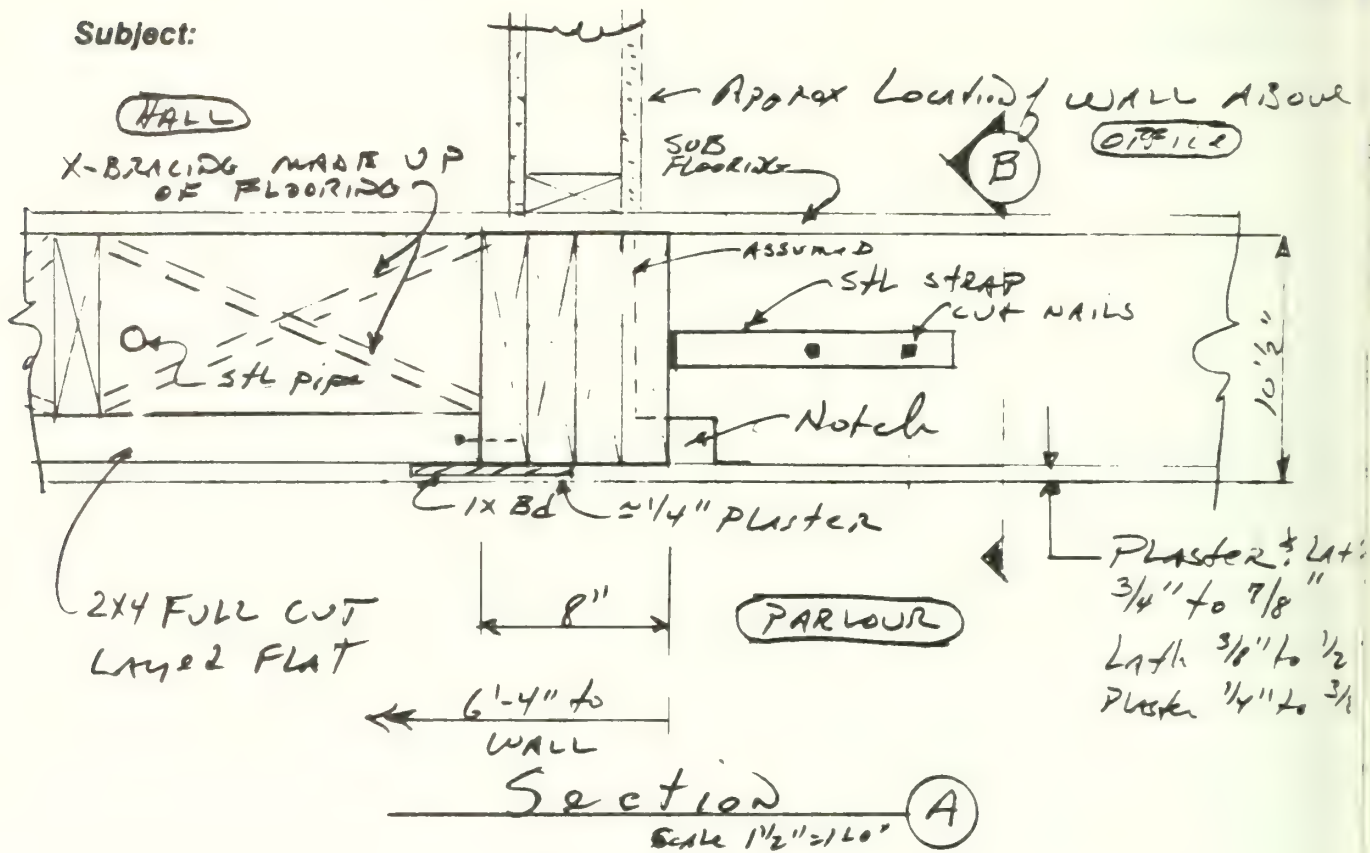
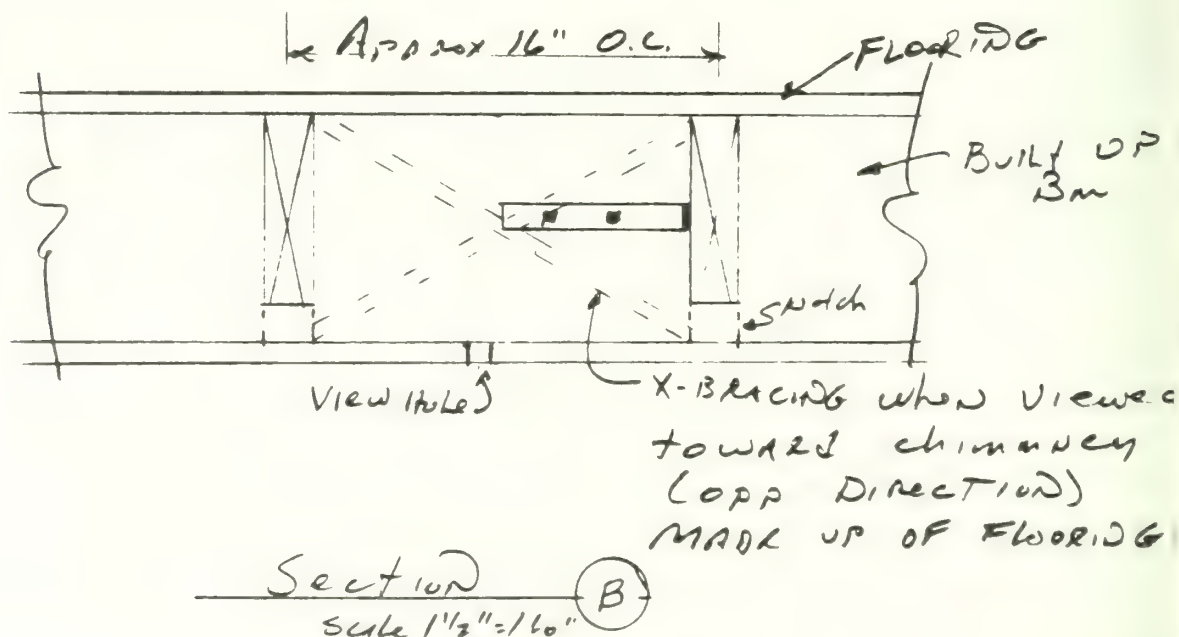
FIG 6

The hallway framing adjacent to the beam seems a bit odd since it spans parallel to the hallway with flat 2x4's spanning perpendicular (see "Appendix G, Structural Calculations," figure 6). Additional investigation would be required to determine the exact hallway load paths. Regardless, the beam which replaced the bearing wall is grossly inadequate. Based on the information currently available, it is somewhat baffling why there has not been additional visible distress in this area (see plate SP-27). Added stiffness could be occurring from the wall section above, which is in line with the beam. Since the beam placement was a remodel, there is the possibility that some of the dead load might have been transferred to secondary load paths. For example, the second-floor wall may be partially supported from the third floor.
